## Topic: A1784 Correct Fitment

When Removing and replacing the air filter on a Ford Ranger or Mazda BT-50 from 2011 onwards, extra care has to be taken to ensure the filter is sitting properly and performing as intended.

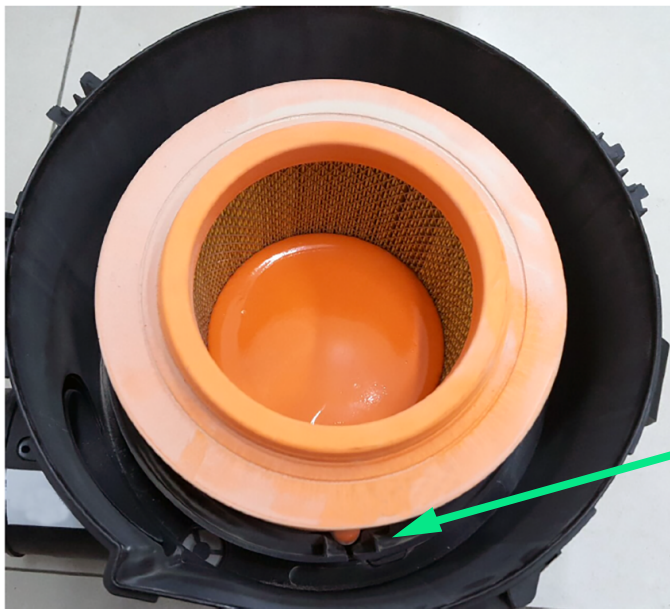
TAB IN GROOVE FITTED CORRECTLY

Make sure every time the filter is replaced that it is sitting evenly flat and that the locating tab is in the right place. Refer to images below.
