Ryco N99 MicroShield® ***Cabin Air Filter***

In-vehicle air purification against biological contaminants

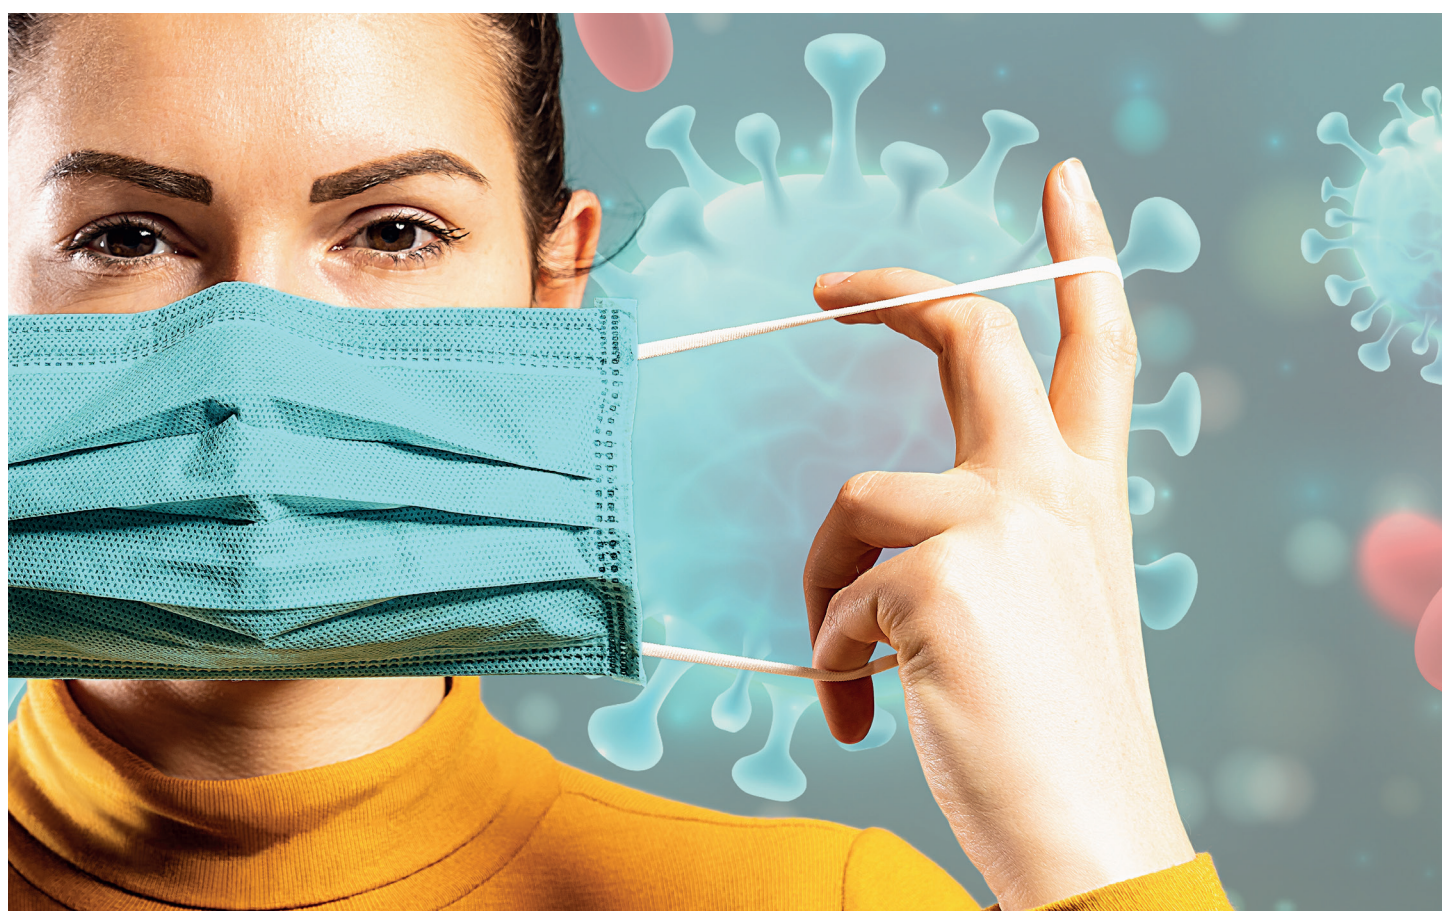
Ryco MicroShield

Anti-Viral

Anti-Bacterial

Medical Grade Media

Odour Barrier

≤ 0.3 Micron

Ryco Microshield Cabin Air Filters consist of three levels of protection against biological contaminants.

1. Anti-viral layer with natural polyphenol extracts eliminate virus, bacteria and allergens
2. Activated carbon odour and gas absorption/barrier
3. Medical grade melt-blown electrostatically charged 0.3 micron layer
